Phase I Inspection Report  
Mud Lock C&S Canal Dam  
Oswego River Basin, Cayuga County, NY  
Inventory No 416

5. TYPE OF REPORT & PERIOD COVERED  
Phase I Inspection Report  
National Dam Safety Program

14 September 1981

PHASE I INSPECTION REPORT  
NATIONAL DAM SAFETY PROGRAM  
MUD LOCK C&S CANAL DAM  
I.D. NO. NY 416  
# 64A-369  
OSWEGO RIVER BASIN  
CAYUGA COUNTY, NEW YORK

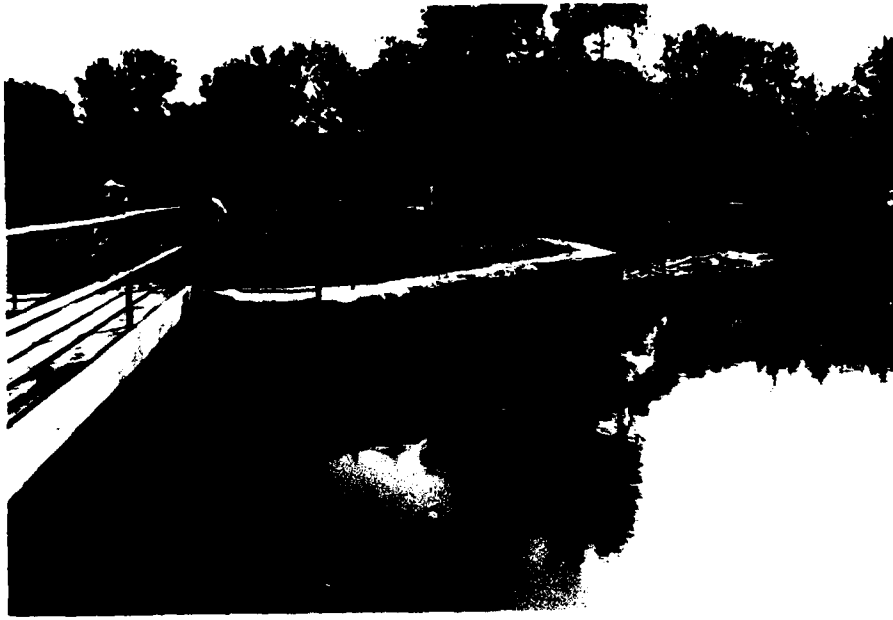
**UPSTREAM RETAINING WALL AND RIGHT ABUTMENT**

The grass cover on the right embankment was recently cut, which facilitated inspection of this side of the dam. The crest is relatively flat, with no apparent irregularities on the surface. Minor soil erosion due to runoff was noted behind the upstream retaining wall of the right abutment. Some vegetation is growing on the riprap slopes upstream and downstream of the retaining walls.

The concrete side walls and the retaining walls, upstream and downstream, are in fair condition. Vertical construction and/or expansion joints have opened up at several places along the wall, particularly on the right embankment. Severe spalling is occurring in these areas, as well as along the upper edge of the upstream wall and along the entire surface of the downstream wall leading to the taintor gates. Heavy efflorescence was also noted on the walls.

- c. All accumulated debris should be removed from the vicinity of the taintor gates.
- d. The end seals on the taintor gates should be replaced.
- e. The area of minor erosion behind the upstream retaining wall on the right abutment should be backfilled and reseeded.
- f. Trees and brush growing on the crest of the left embankment, and on the downstream toe of both embankments should be removed.
- g. An emergency action plan should be developed for the notification and evacuation of downstream residents.

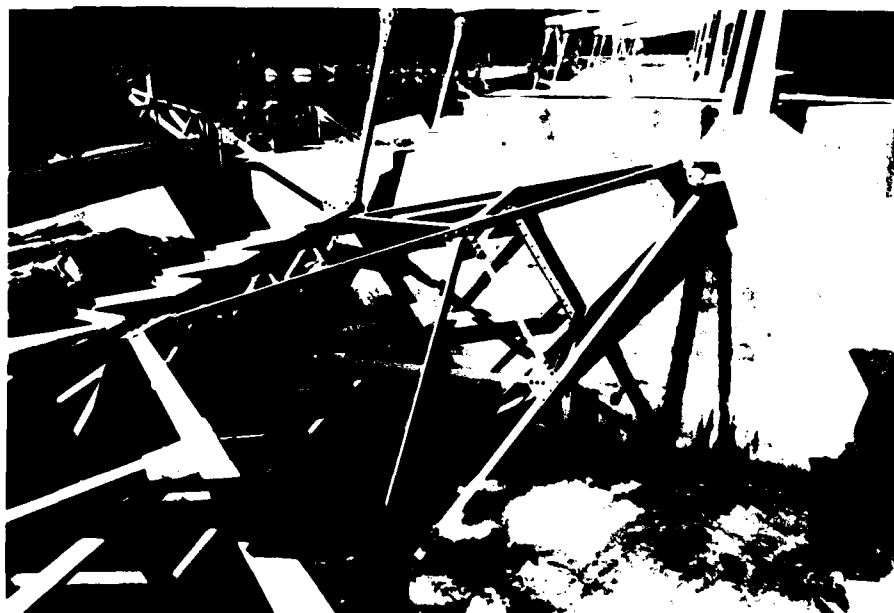
**TAINTOR GATE (OPENED APPROXIMATELY 3 INCHES)**

At the time of the inspection, two of the six taintor gates were slightly open to permit a minimum flow of 200 cfs into the Seneca River. Heavy leakage was occurring around the end seals of three of the gates.

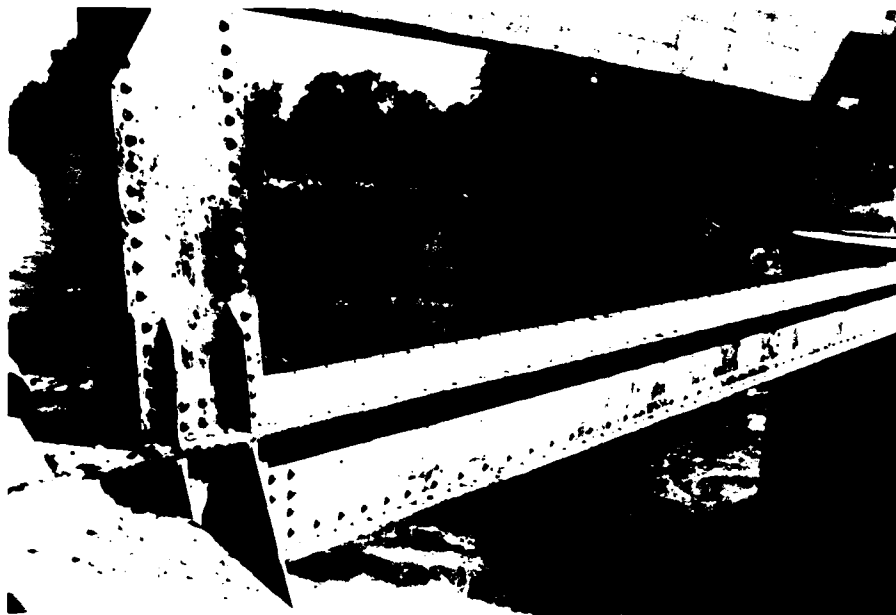
The rack and pinion mechanisms which operate the taintor gates appear to be in good condition, with only minor amounts of rust in some areas. Parts of the superstructure on the taintor gates have been recently painted, however, rust is visible in other areas of the beams. The steel plates on the downstream side were also rusted. The upstream side of the gates were submerged. All six counterweights on the taintor gates showed

RUST ON COLUMNS AND BEAMS

- a. Cracks and spalling on the visible portions of the concrete retaining walls, piers, and counterweights should also be repaired.
- b. All steel work on the superstructure should be sandblasted, primed and repainted where necessary, to prevent continued rusting and pitting.

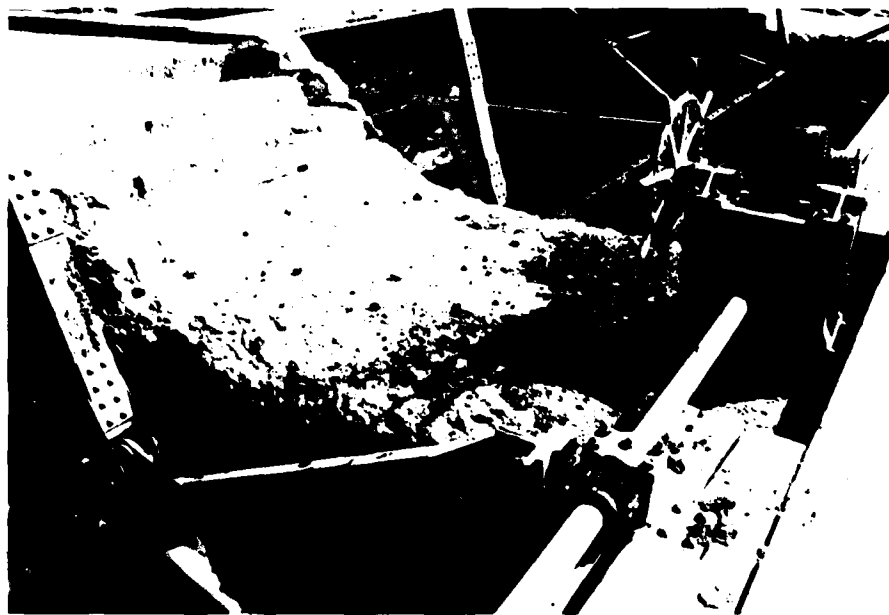
The spillway is in fair to poor condition, with the major deficiency being the deterioration of the concrete piers. Heavy spalling occurs on the tops of the piers, particularly toward the center of the spillway and at the gate bearing points. Efflorescence was noted through horizontal fractures in the sides of the piers, with minor amounts of vegetation growing in the cracks. The lower two-thirds of the piers, and the sill, could not be inspected due to the tailwater elevation. The submerged portion of the piers and sill was reportedly inspected in 1973 by towing a cofferdam barge upstream of the spillway and thereby cutting off the flow. Substantial leakage beneath the sill was reported in the 1973 Condition Report, which is included in Appendix E.

SPALLING ON CONCRETE PIER

- a. Concrete Surfaces Moderate to severe spalling on concrete piers, both upstream and downstream, particularly on edges and corners. Heavy efflorescence on pier walls within each bay.
- b. Structural Cracking Minor cracking, generally horizontal along pier walls. Horizontal cracks also noted on counterweights, which are also spalled at lower corners.
- c. Movement - Horizontal & Vertical Alignment (Settlement) none noted
- d. Junctions with Abutments or Embankments junctions appear to be sound
- e. Drains - Foundation, Joint, Face none
- f. Water Passages, Conduits, Sluices abandoned fish ladder at left abutment, partially backfilled. Some clear seepage noted through fill
- g. Seepage or Leakage leakage visible around end seals of tainter gates. seepage beneath sill has been reported in old inspection records since completion of construction
